# Manhole Inspection Summary

Manhole # S59G\_\_009MH

Insp Date: **7/23/08 9:44 AM**

**Location** Address: **300 s lehigh st**

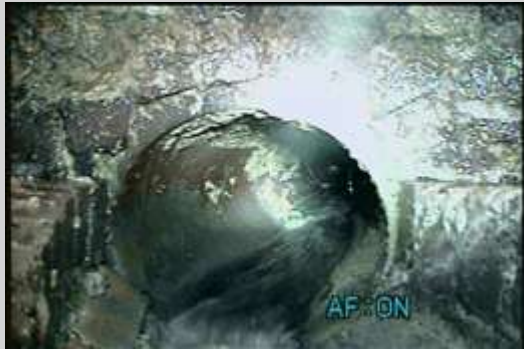
12 O'Clock Outflow

8 in. Circular Gravity Sewer  
Pipe Out @ 12 O'Clock

Pipe Material: **Clay** ☐ Pipe Lined

Invert Depth: **12.75** (ft.) Flow Characteristics: **Fast**

Deposits: ☒ None ☐ Mud ☐ Sludge ☐ Debris ☐ Grease

Infiltration: **None** Pipe Seal Cond: **Unknown**

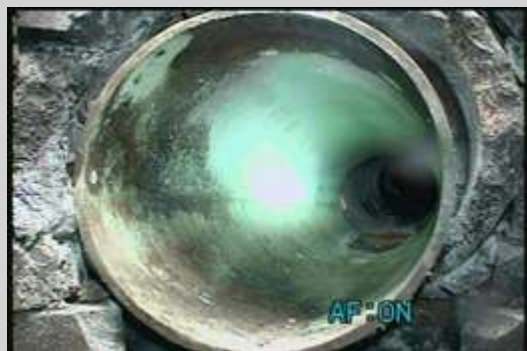
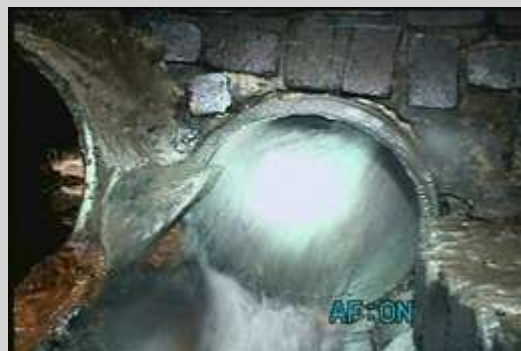
6 O'Clock Inflow

8 in. Circular Gravity Sewer

Pipe In @ 6 OClock

Drop In @ 6 OClock

Pipe Material: **Clay** ☐ Pipe Lined

Infiltration: **None** Pipe Seal Cond: **Unknown**

Drop Condition: **Open**
